Biological Resources Assessment and Preliminary Arborist Report

**Assessment of Potential Impacts on Biological Resources
Atherton Cartan Field Upgrade Project
Atherton, California**

Preliminary Arborist Report

**Cartan Field Upgrade
Menlo College
Atherton, CA**

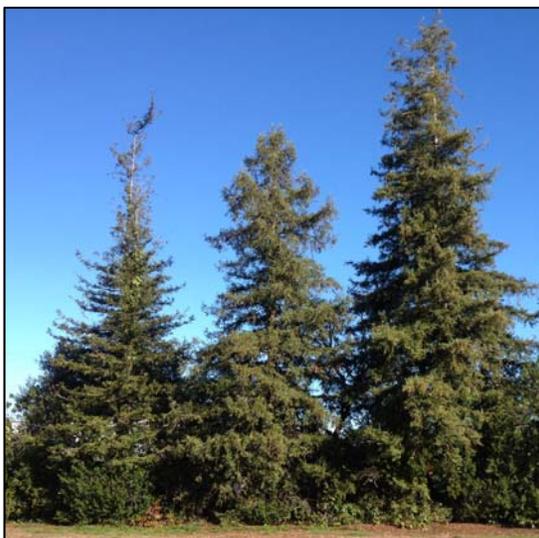
Photo 1: Coast redwoods #58 and 59 (right and center) were in good condition with good form and dense crowns; tree #61 (left) was in fair condition with a thin crown and a bent top.

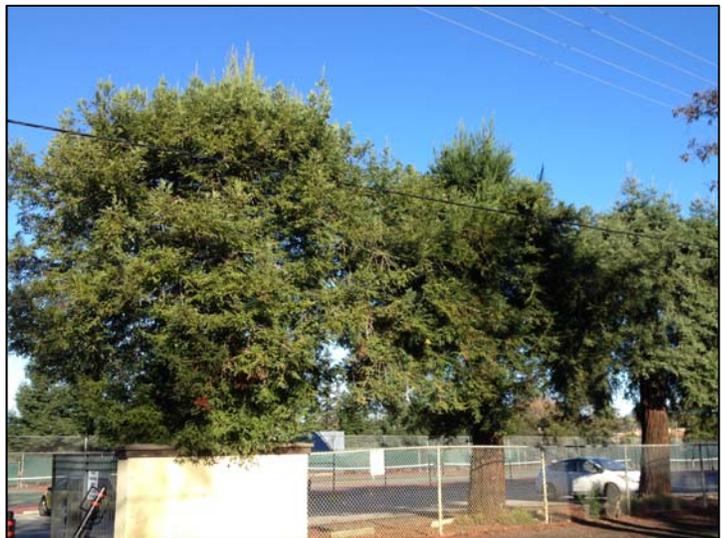
Photo 2: Coast redwoods along Alejandra Ave. had been topped for utility line clearance. They had dense crowns and good foliage color and were in fair condition.

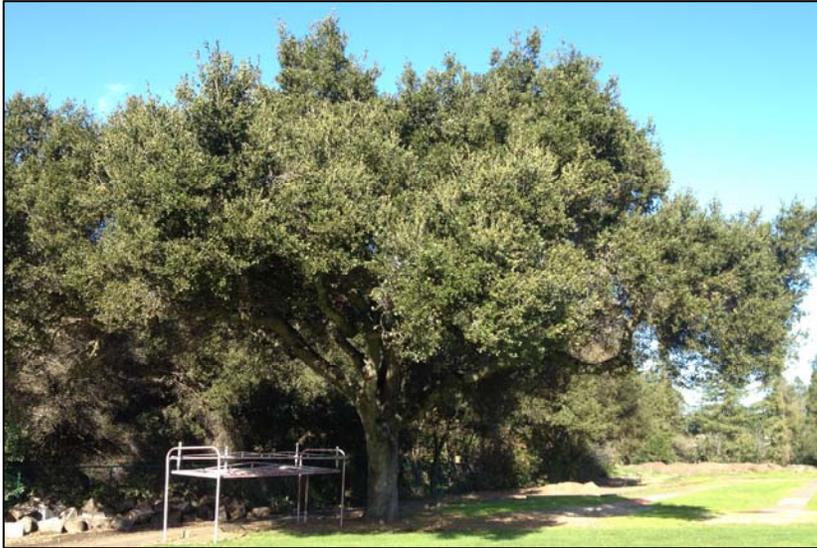
Photo 3: Coast live oak #106, located near the canal along the north property line, had good form and structure and a dense canopy. It was in good condition.
